STS-106/2A.2b Flight Readiness Review

August 29, 2000

Johnson Space Center

EMU Oxygen Contamination

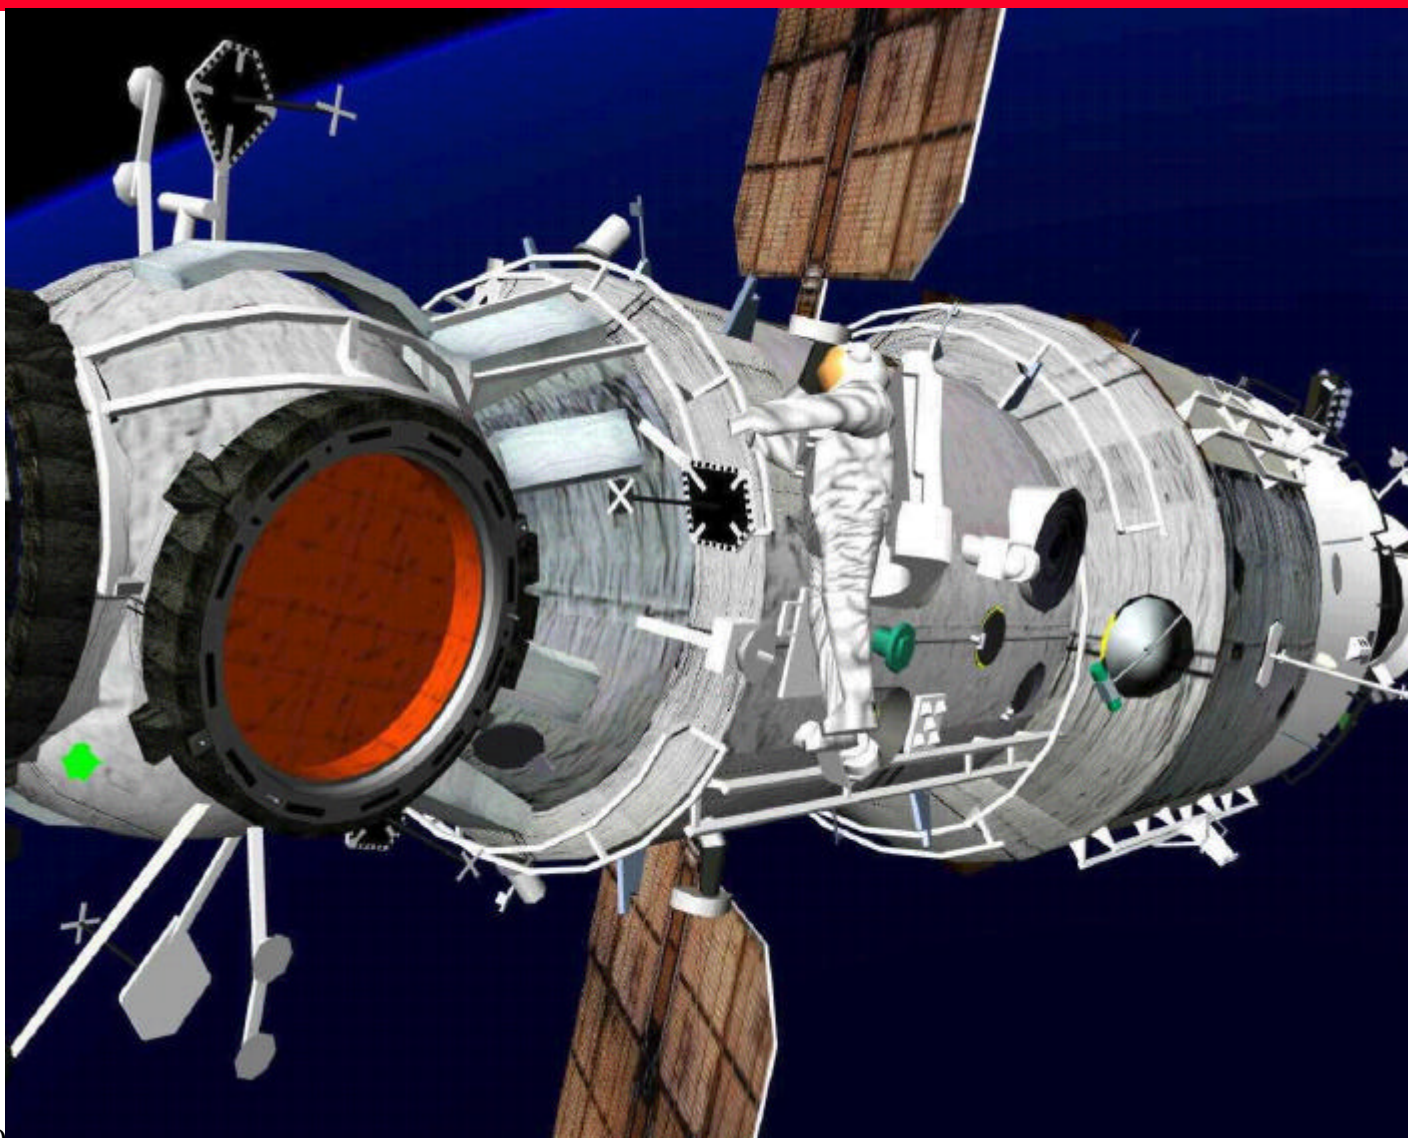
SM -X Docking Target Photos

12.	SM TV Target launch restraint release	<ul style="list-style-type: none"> Target pyro has fired, but not confirmed to be in the deployed position. 2A.2b looking at a plan for completing the deployment and will present to EVA CCB on 7/28.

- Confirmation from Russian telemetry and through verbal discussions that the launch lock pyro has fired
- Target verified in near stowed location by FGB docking camera
- Target data:
 - Deploy speed: 99° in 1.5 seconds (~ 1.7 ft/s)
 - Travel Path: 900 mm at tip of target
 - Deploy force: 3.5 kg (< 8 lbs)
- Crew will visually inspect the area and report to MCC-H
- Crew is cleared to touch target and manually push into position
- Procedure has gone through EVA community review for concurrence (EVA CCB)

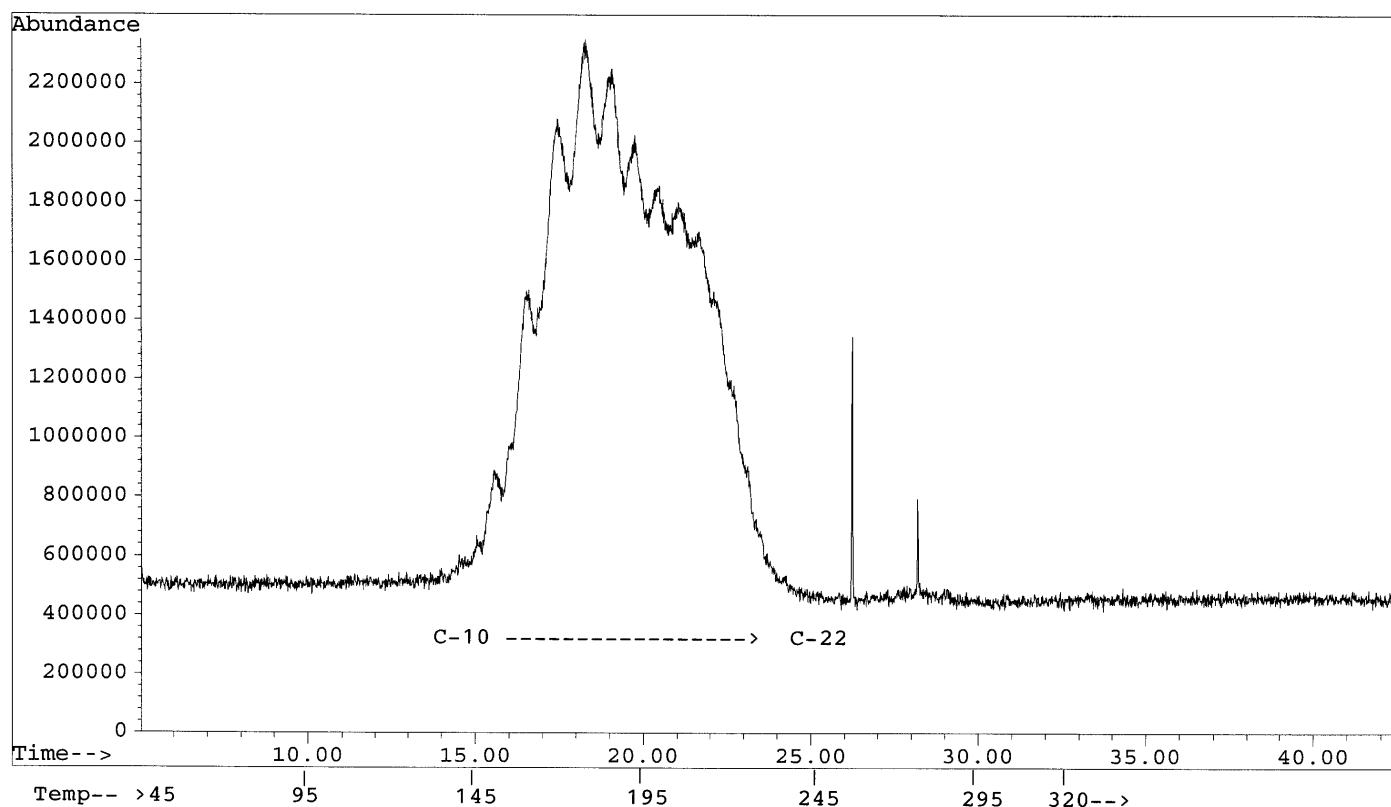
Chromatogram #3 - SOP Regulator S/N 102 Outlet Port

- Results indicate that no single component oil caused the observed contamination
- Results indicate that no single multi-component oil caused the observed contamination
 - Hydrocarbon links found are from C10-C34
- Results support contamination by multiple oil types (multiple sources and/or episodes)
- Gas Chromatography/Mass Spectrometry utilized to analyze contamination
